INTERNAL AUDIT TEAM SUMMARY

SPECIAL REPORT
QUALITY AND SHE
SHEQIA01/2015

GEOSERVE DRILLING SERVICES

PROJECT REPORT UPDATE - CIMERA KARIN PROJECT - ZANDFONTEIN 89

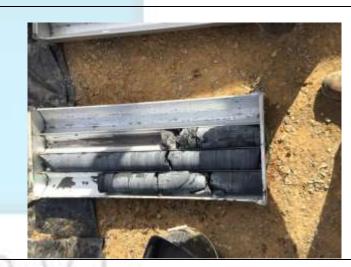
Continue drilling PQ3 to competent rock formation in order to ream 5'9/16 insert 141mm casing.

Hole current depth 59.8m.

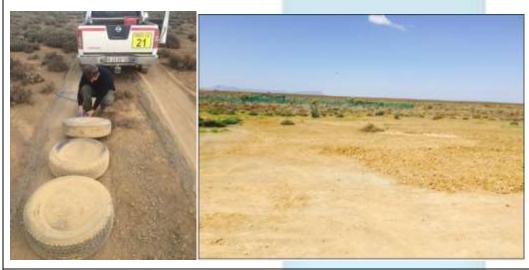
14 - 16 SEPTEMBER 2015 - CONTINUE SITE REHABILITATION
