## **CIMERA – KARIN PROJECT ECO CHECKLIST # 3 CLOSURE AND AUDIT**

**ECO SERVICES FOR THE DRILLING OF A RESEARCH BOREHOLE ON FARM  
ZANDFONTEIN NO. 89, CERES DISTRICT, WESTERN CAPE: PLANNING, OPERATION AND  
REHABILITATION PHASE.**

**DATE OF SITE VISIT(S): 17/09/2015**

**DATE OF ISSUE: 28/09/2015**

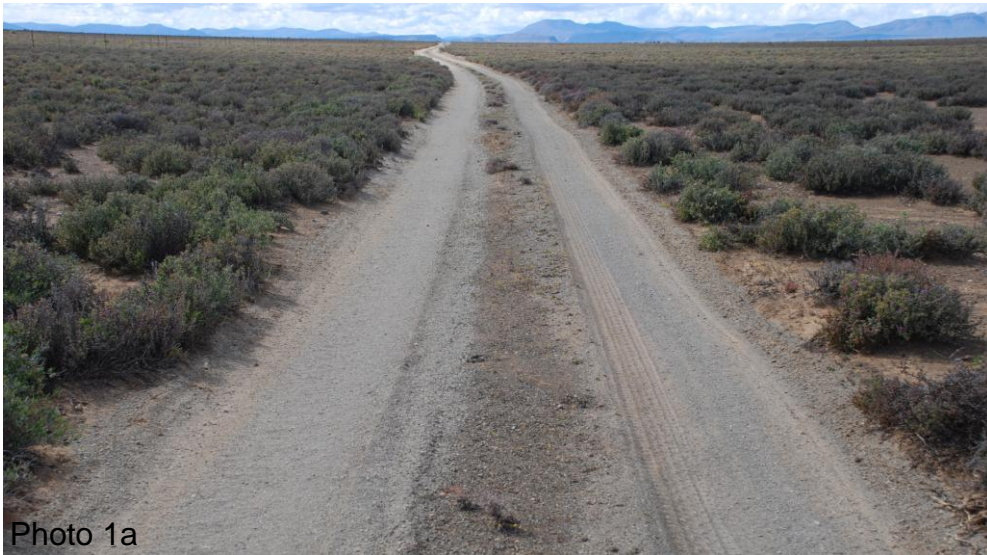
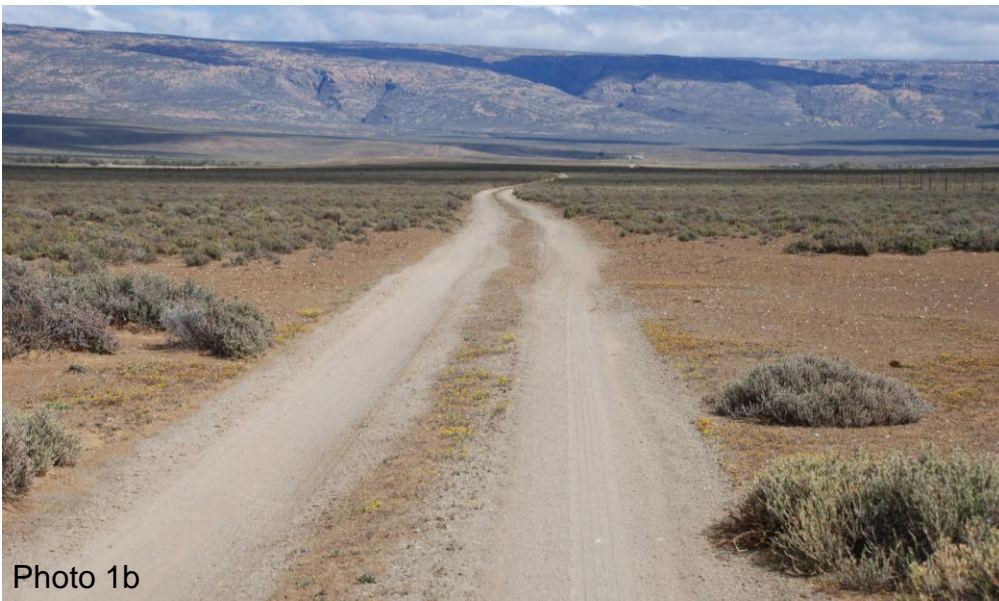
Photo 1a

**Photos 1a and 1b:** The rust in the internal access tracks on farm Zandfontein have been successfully levelled by running three tyre casings filled with concrete over each track of the “twee-spoor” farm track. No damage (as a result of the flattening of the ruts) to the vegetation occurring on the “middelmannetjie” of the “twee-spoor” track was observed.

- As per the recommendations made by the ECO in the second checklist, Geoserve personnel have successfully rehabilitated the two access roads used to and from the drill site by filling three used tyre castings with concrete and dragging them in series across the ruts of each track with a 4X4 vehicle.

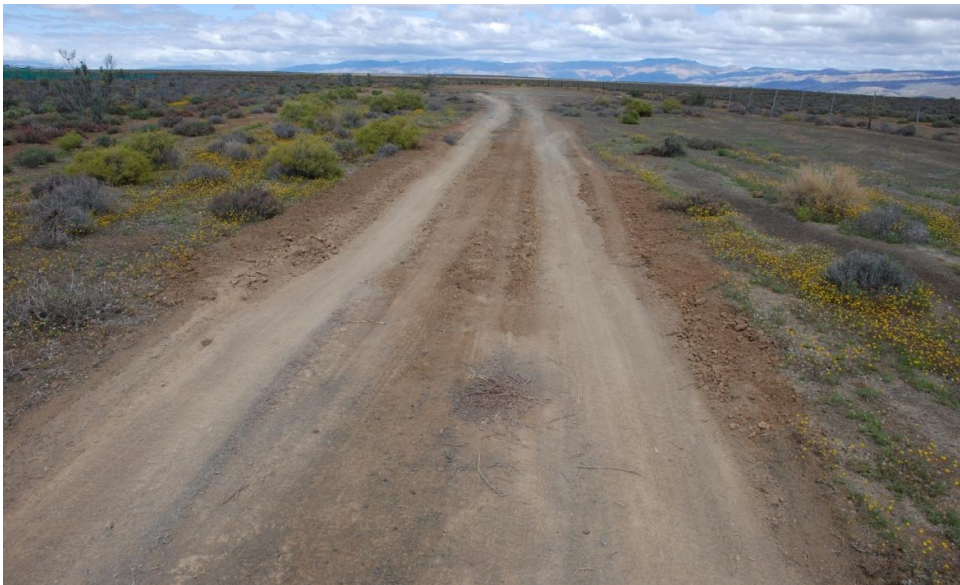
- The vegetation growing on the “middelmannetjie” of the “twee-spoor” tracks were not damaged by the tyres.
- No damage was noted at the areas of the access road prone to water logging after rains. Thus, no corrective action was deemed necessary.

**Photo 2:** No damage was noted at sections of the access road prone to water logging (outlined above).

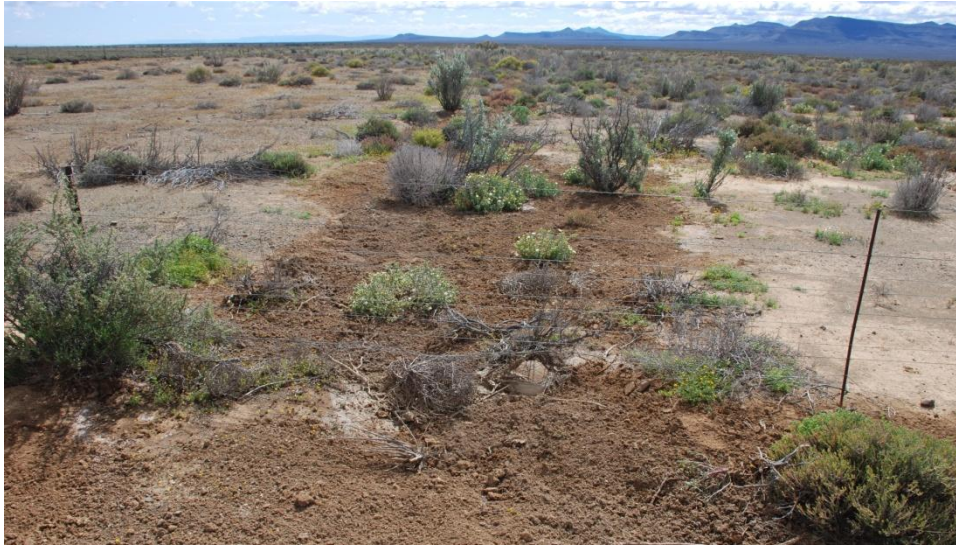
- A third fracture zone was encountered at a depth of approximately 660m on 10 September 2015 near the base of the Eccu.
  - This fracture zone yielded approximately 24200 litre of clear groundwater (±40°C) per day (artesian), which was re-directed off site via a trench to a small natural drainage channel.

**Photo 3:** The artesian groundwater flowing from the borehole was directed along a natural secondary drainage line. The borehole was subsequently sealed, cased and capped. The groundwater has subsequently dried.

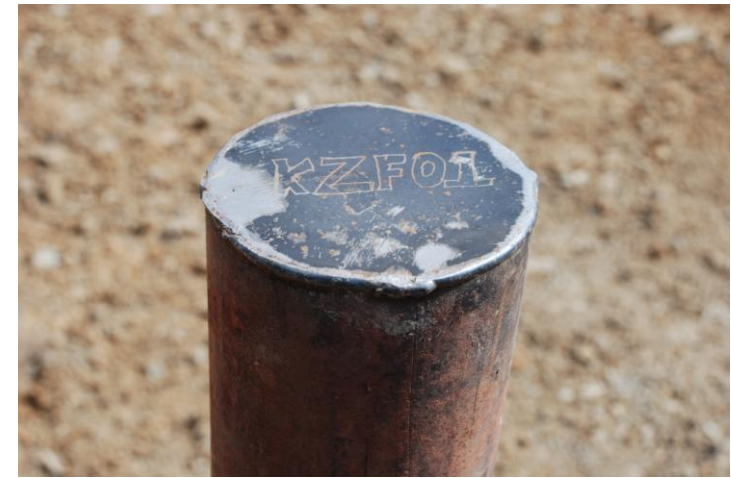
- The upper ±30m of the borehole was filled with clean 19mm stone.
    - The borehole was successfully sealed off and no artesian flow was noted.
- The five water samples taken during the drilling process showed total petroleum hydrocarbon (TPH) levels below the recommended norms (GN No. 331).

**Photo 4:** The borehole was cased-off and sealed by welding a steel cap onto the casing. A number of the borehole was engraved onto the cap (KZF01 – Karoo Zandfontein Farm Borehole No. 1).

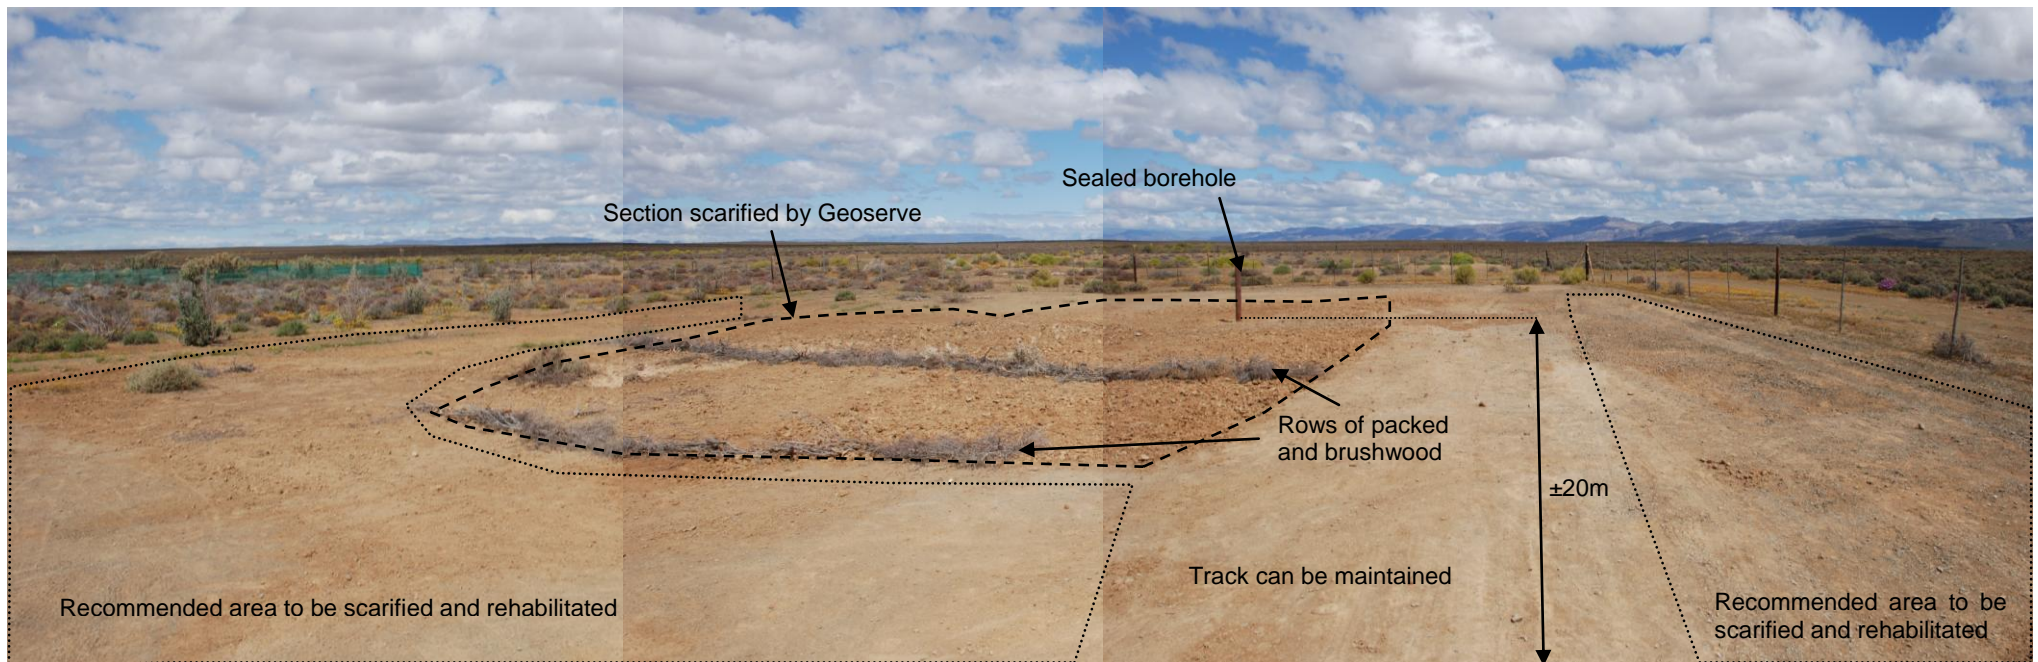
- During the site visit on 18 September 2015, the ECO packed dead pieces of brushwood in two rows (each, 10-13m in length and parallel to one another but at right angles to the prevailing winds) on the scarified denuded soil.

**Photo 5:** A section surrounding the closed borehole had been scarified by Geoserve. Two rows of brushwood were packed over the scarified area at right angles to the prevailing winds to assist natural succession of plants. The seed collected during the ECO site visits were broadcast between the brushwood to hopefully germinate.

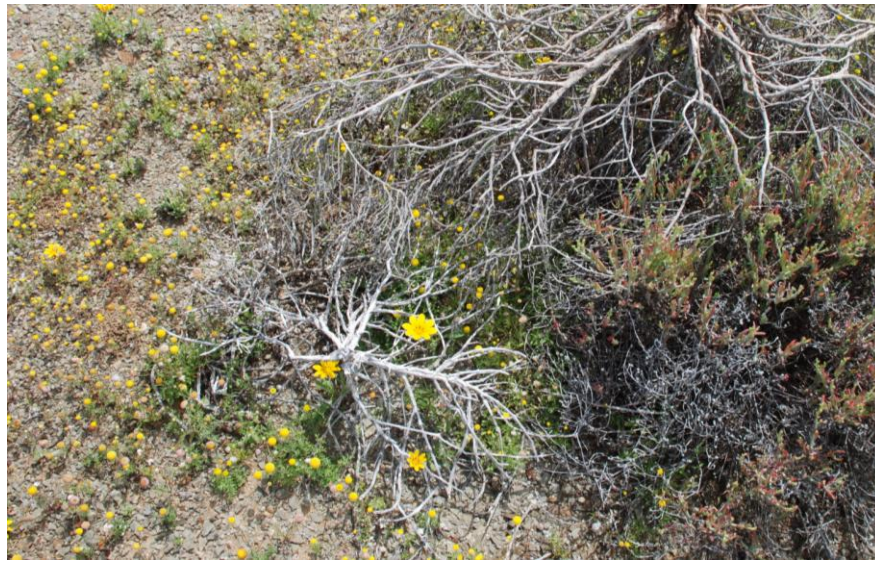
- The seed collected during site visits was broadcast among the rows of brushwood.
  - The brushwood will provide a micro climate in which additional seeds blown into the area will be trapped, germinate, and grow.

**Photo 6:** An example of the natural succession of the germination of seed trapped by brushwood. The brushwood also forms a stable microclimate for the germination and protection of seedlings of pioneer and climax vegetation.

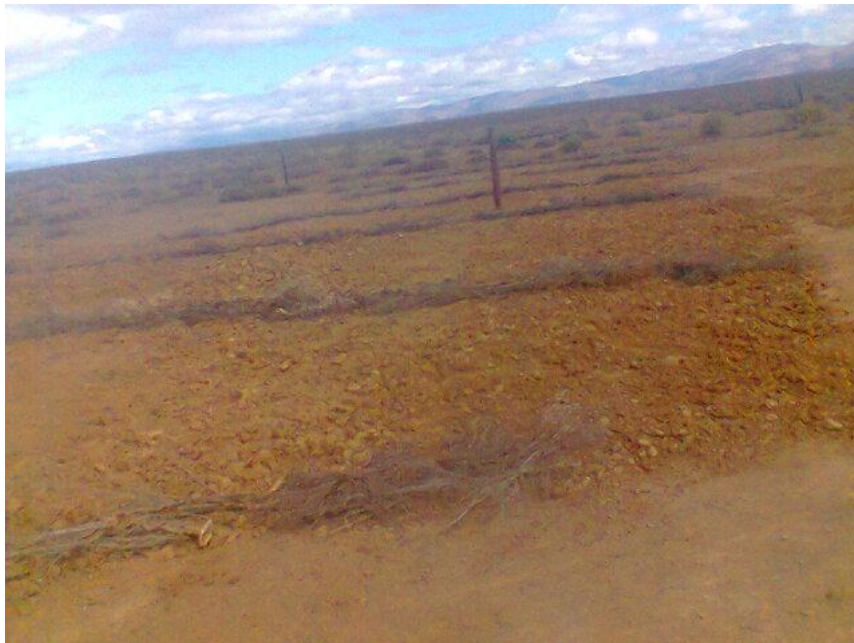
- The site was subsequently successfully rehabilitated (Geoserve completed the scarification and rehabilitation of the denuded areas on 19 September 2015).

**Photo 7:** Subsequent to our recommendations, Geoserve completed the scarification and rehabilitation of the drill site by means of packing rows of dead brushwood on 19 September 2015. The brushwood and scarified areas forms “roughage” to trap seeds for later germination and natural succession of indigenous plants.

- The ECO recommended to the Geoserve SHE Officer and two of his personnel that the remaining trampled site of the drill camp should also be scarified and that additional brushwood rows should be made parallel to one another, approximately 3m apart.

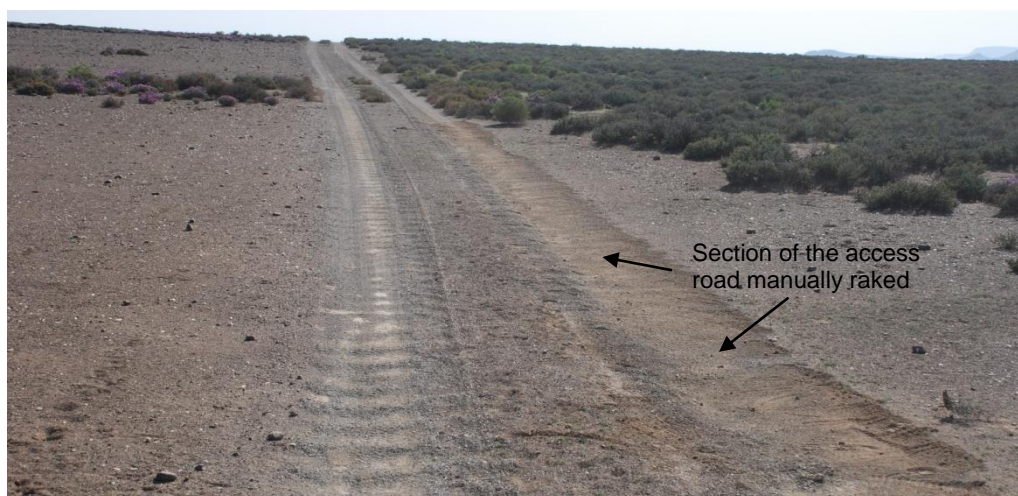
- As a temporary solution, Geoserve personnel experimented flattening the ruts by manual raking. However, this was time consuming and not very effective.

**Photo 8:** Geoserve personnel experimented flattening the ruts by manual raking, which was time consuming and not very effective.
