CIMERA – KARIN PROJECT ECO CHECKLIST # 1

**ECO SERVICES FOR THE DRILLING OF A RESEARCH BOREHOLE ON FARM
ZANDFONTEIN NO. 89, CERES DISTRICT, WESTERN CAPE: PLANNING, OPERATION AND
REHABILITATION PHASE.**

**PREPARED FOR: UNIVERSITY OF JOHANNESBURG
DRILLING CONTRACTOR: GEOSERVE**

DATE OF SITE VISIT(S): 17/07/2015 & 24/07/2015

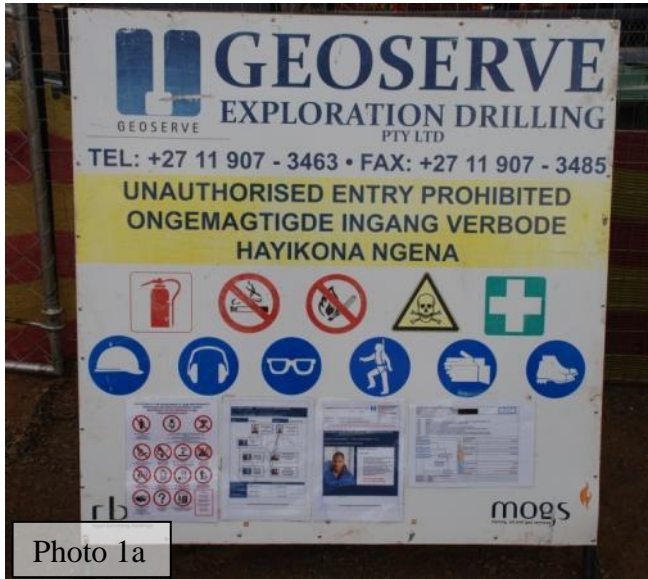
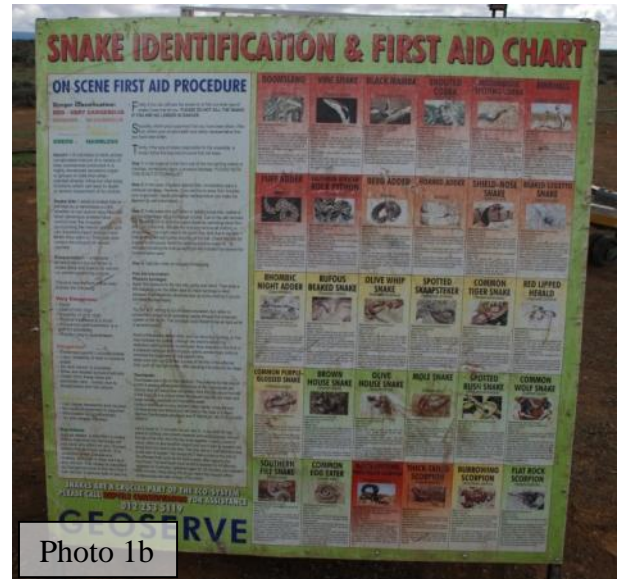
Photos 1a and 1b: An information board, containing the on-site conduct rules, the induction sheet (provided by Withers Environmental Consultants), snake identification and on scene first aid procedures is placed at the site entrance.

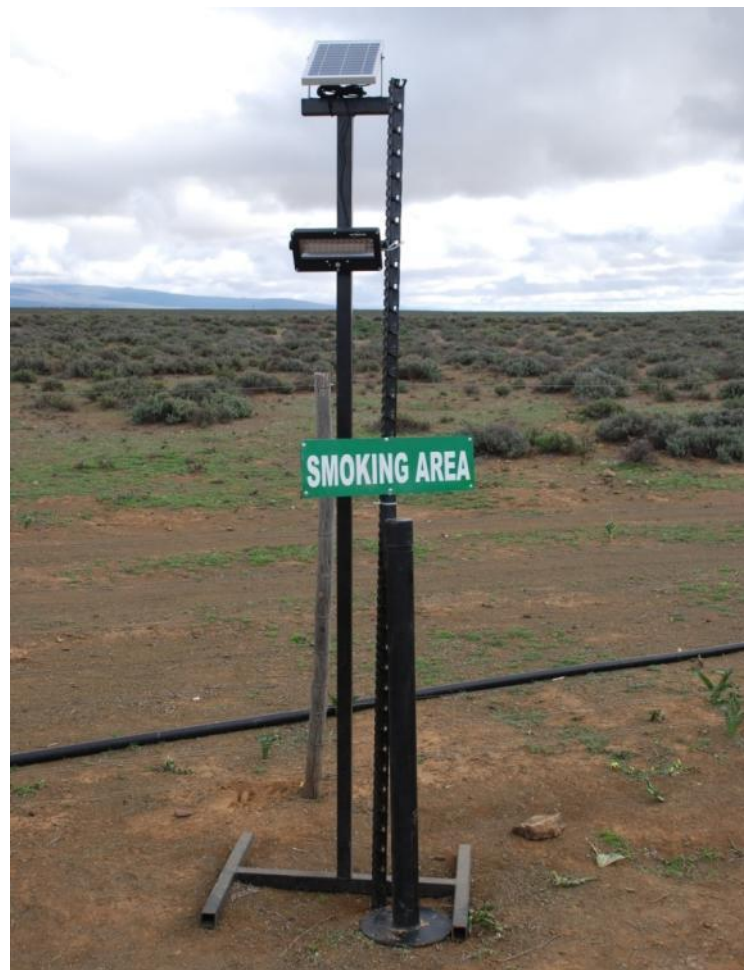
AIM	ACTION TO BE CHECKED BY ECO ⁷	RESP ⁸	ACTION BY	CORRECTIVE ACTION Y/N	COMMENTS
2.4 Prevention of fires (cont.)					
Prevention of fires and burning (cont.)	No open flames are allowed on site, including the use of fires for cooking or heating at or near the drilling site.	GEOSERVE	GEOSERVE, UJ	N	This was explained during the environmental site induction on 17 July 2015 and being adhered to.
	No smoking is allowed near the drill rig, but only in specific demarcated areas. Cigarette butts are to be disposed of in a lidded bin.	GEOSERVE	GEOSERVE, UJ; ECO	N	A designated smoking area has been allocated, away from the drilling area (Photo 2).

Photo 2: The designated smoking area has been fitted with a solar powered light.

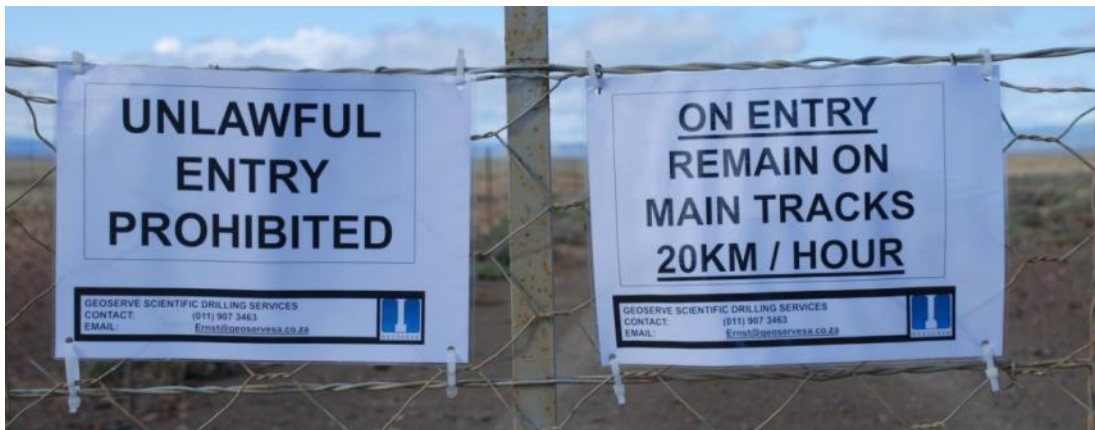
Photo 3: Appropriate signage has been erected at the farm entrance which indicates the speed limit to be adhered to on the property.

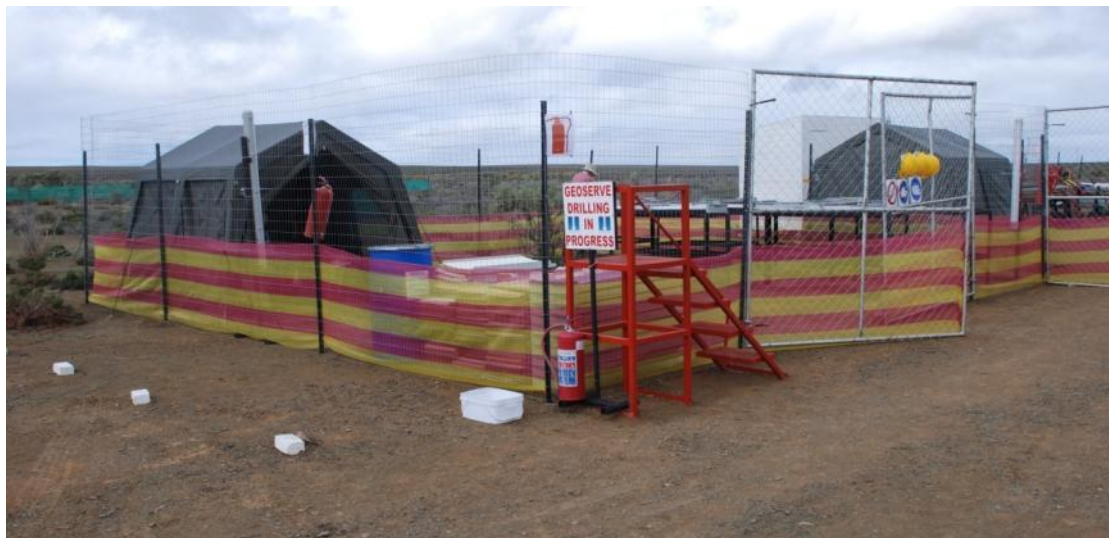
Photo 4: The site has been appropriately demarcated with a security fence and safety netting. The core storage and logging area in the foreground is separated from the drilling area.

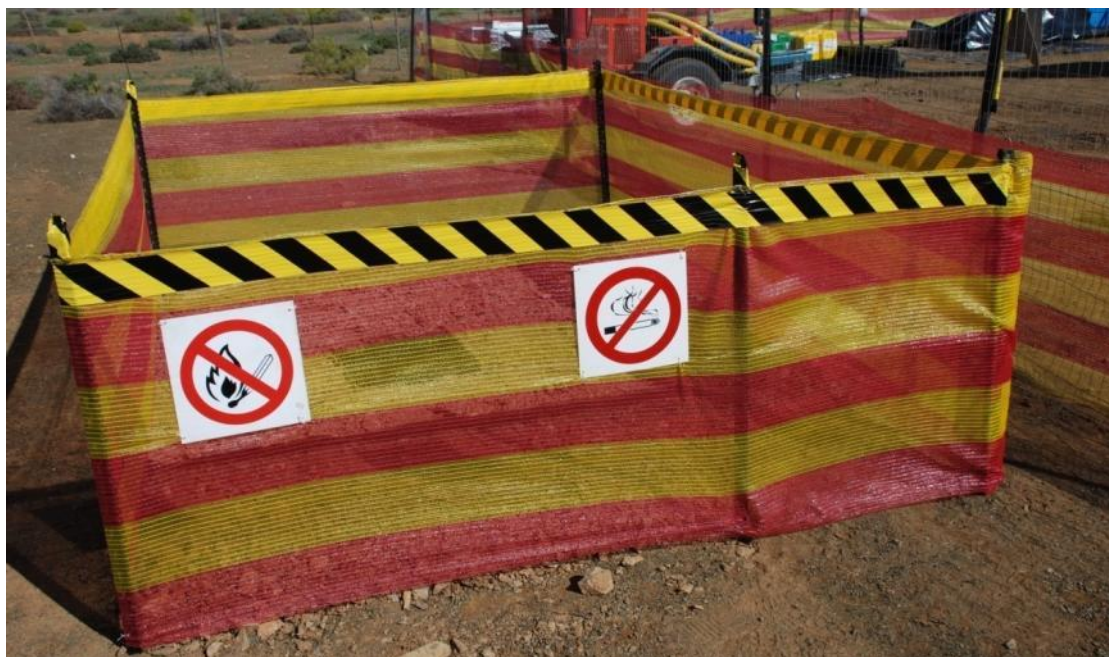
Photo 5: The methane burnout pit is placed on the edge and separated from the drill site and has been demarcated with the appropriate safety netting.

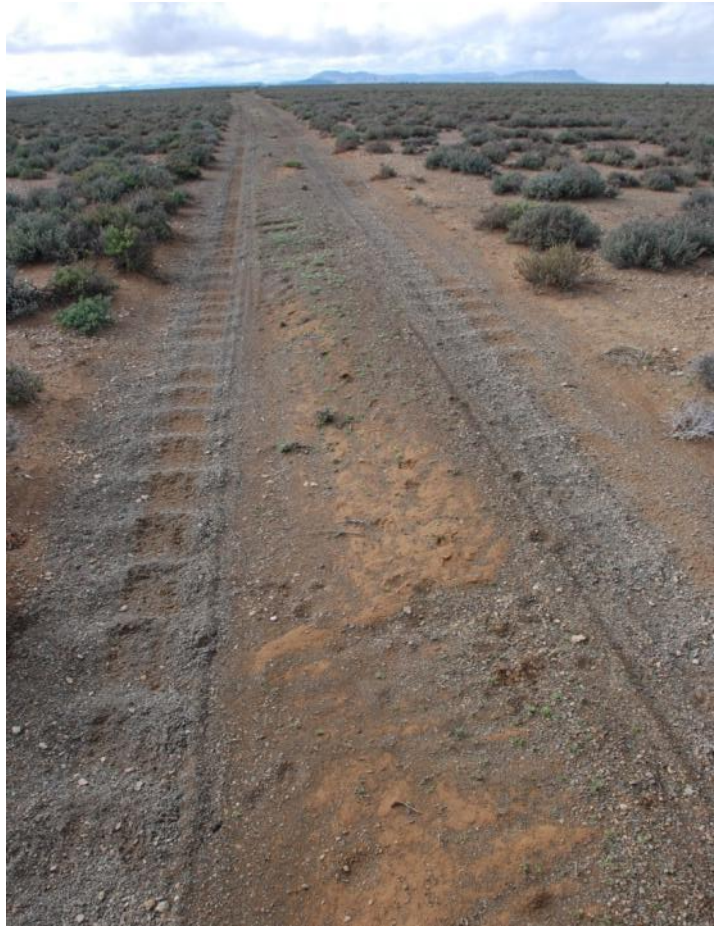
Any deterioration of roads and tracks used during the drilling phase should be rehabilitated as soon as possible, to the satisfaction of the property owner and ECO.	GEOSERVE	GEOSERVE	N	Sections of the access road have started forming ruts (Photo 6) due to the use of construction vehicles (refer to Figure 1). Any ruts should be flattened once the drilling has been completed. Access road areas prone to water logging (Photo 7) should be regularly checked and maintained, if necessary, using local materials to prevent them from destabilising.

Photo 6: Sections of the access road on Farm Zandfontein have started forming ruts due to the use of construction vehicles. These ruts will need to be flattened once the drilling has been completed.

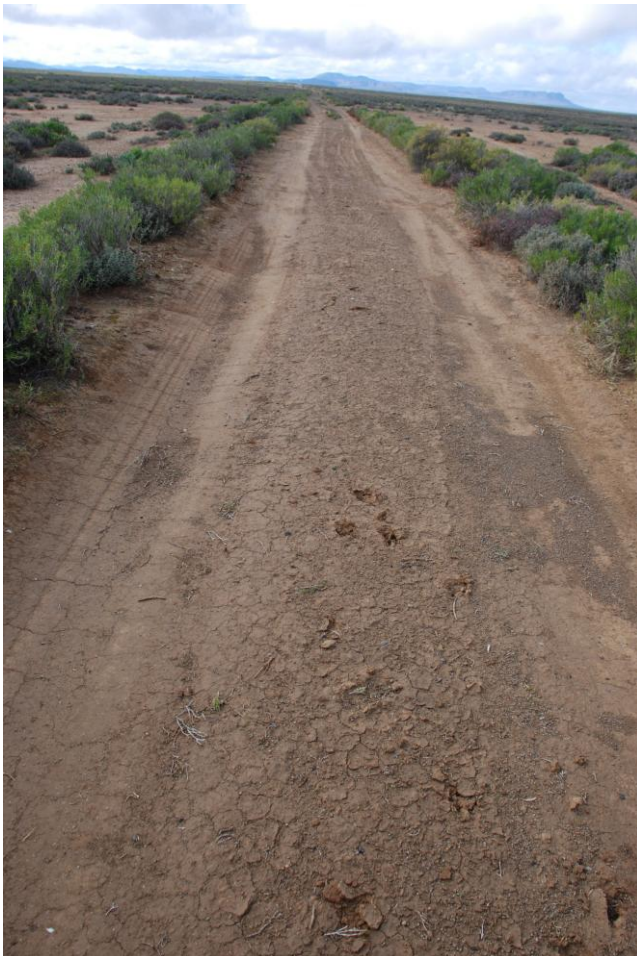
Photo 7: Areas prone to water logging should be regularly checked and maintained, if necessary, using local materials to prevent them from destabilising.

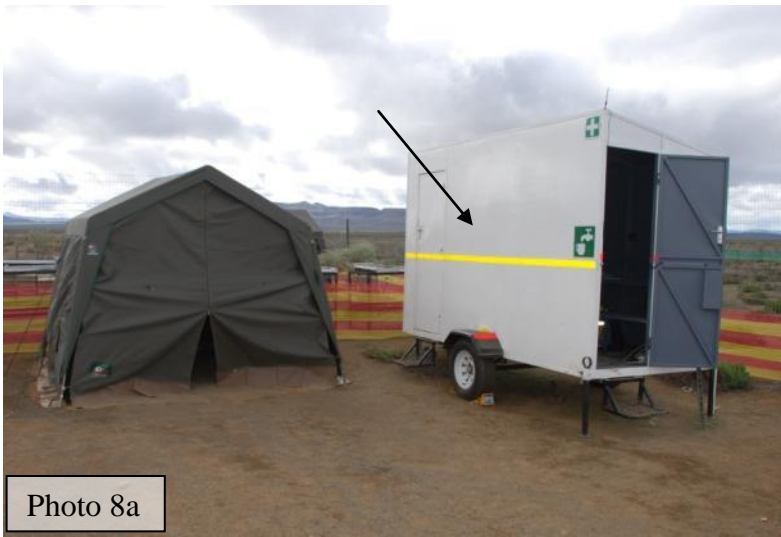
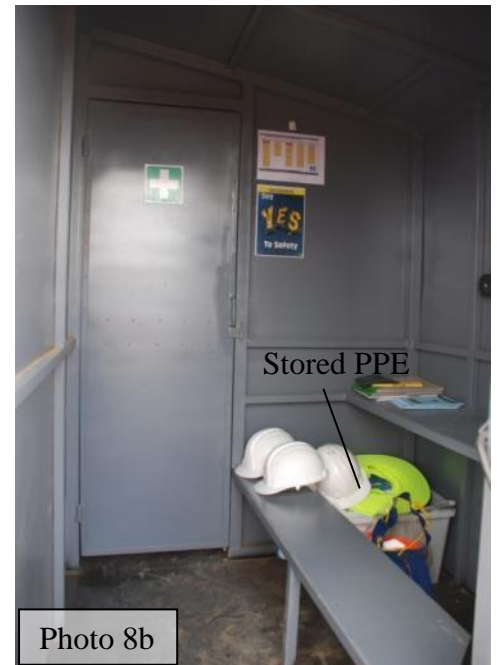
Photo 8a

Health and safety of personnel	The contractor should ensure that adequate Personal Protective Equipment (PPE) is provided to personnel (including the necessary noise protection gear).	GEOSERVE	GEOSERVE, UJ	N	Personal Protective Equipment (PPE) is provided for each staff member and stored in the construction trailer which doubles as a first aid room (Photos 8a and 8b). All personnel use their PPE.

Photos 8a and 8b: Personal Protective Equipment (PPE) is kept in the mobile first aid room (black arrow).

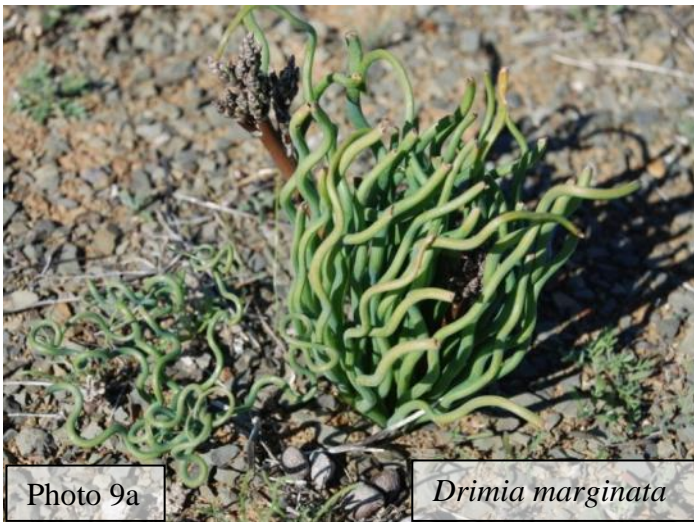
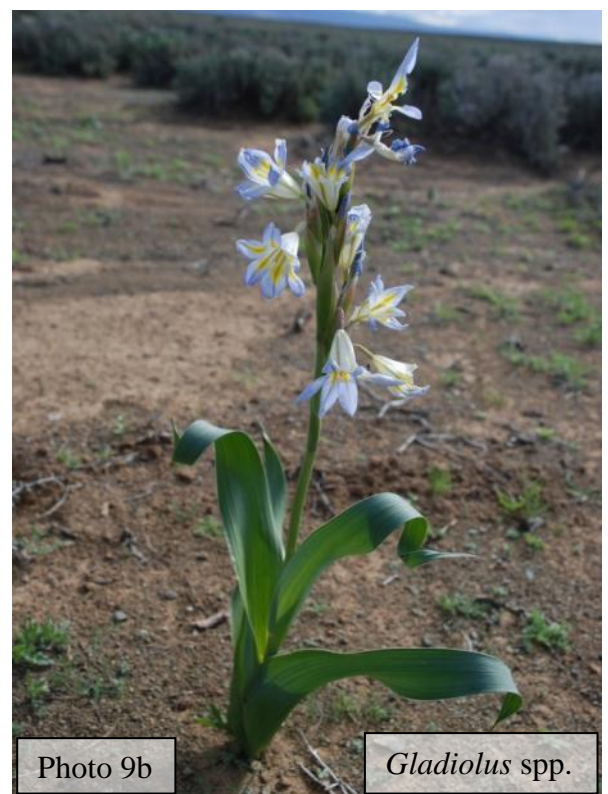
Photo 9a

Photos 9a and 9b: Several Jessop *Drimia marginata* (top) and *Gladiolus* spp. (right) were located on site and transplanted by the ECO within a “nursery area” for later transplanting back to the site.

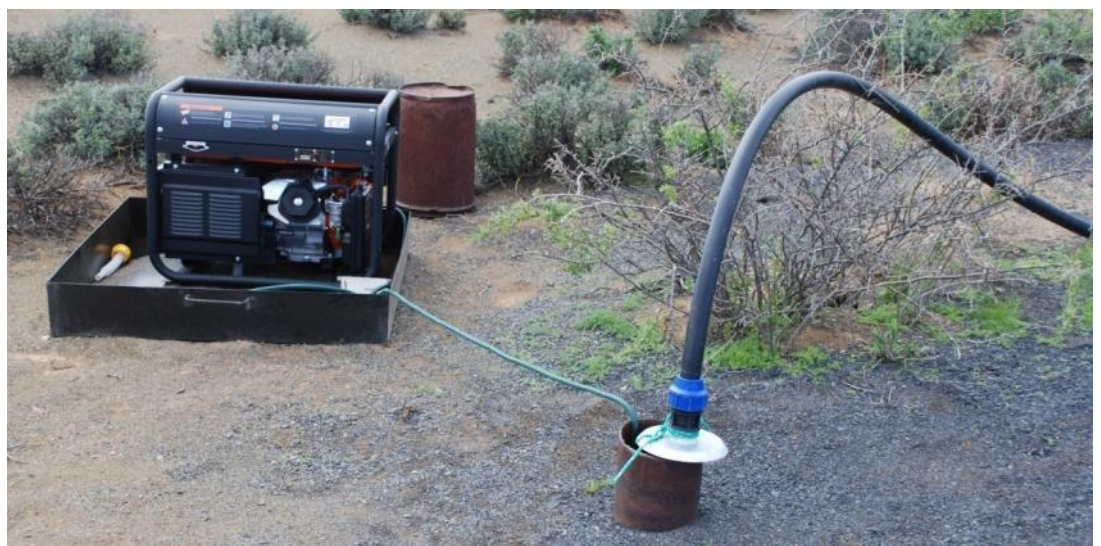
Photo 10: Water for drilling is sourced from a nearby non-equipped borehole. A temporary submersible pump and generator pumps groundwater to the drill site through a PVC pipe laid out on surface.

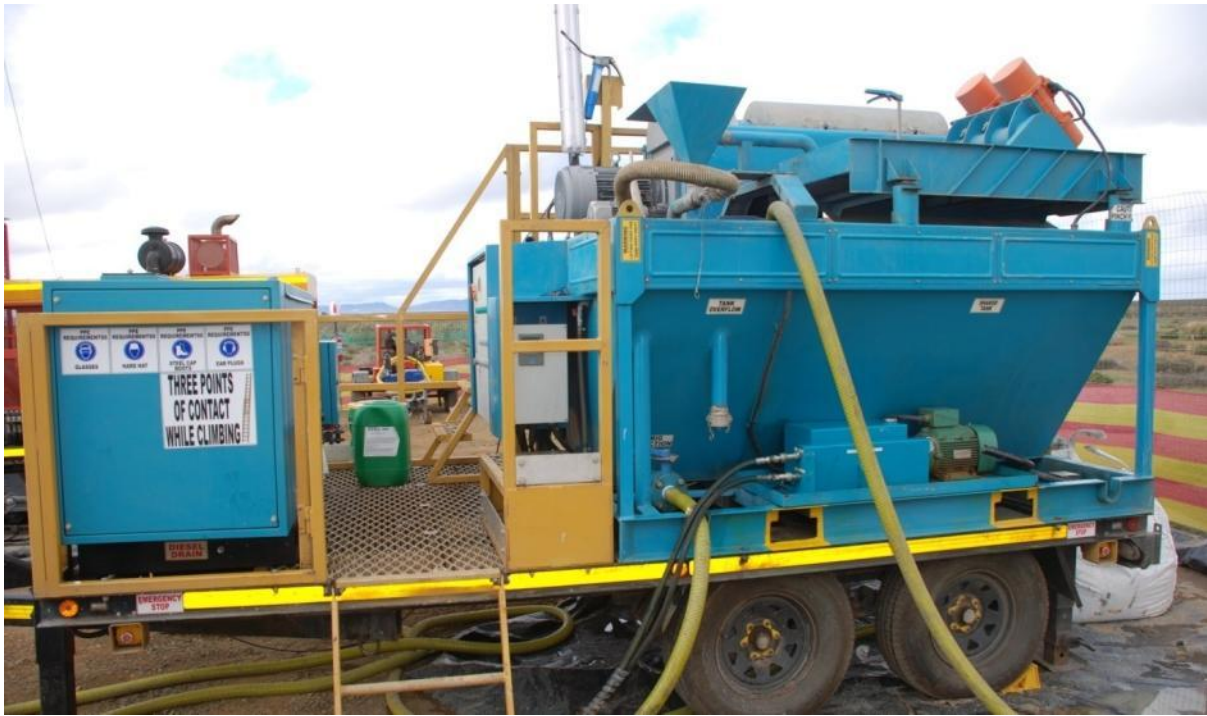
Photo 11: Sludge and drilling water from the core drill hole is circulated by pumping it to the Solid Removal Unit (SRU). The sludge and any larger particles are separated from the drill water which is re-circulated to the drill hole.

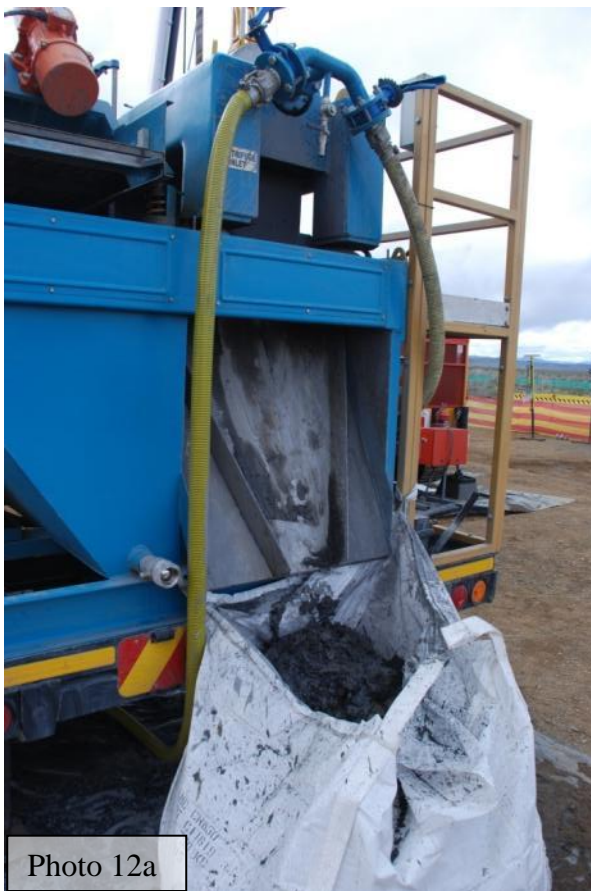
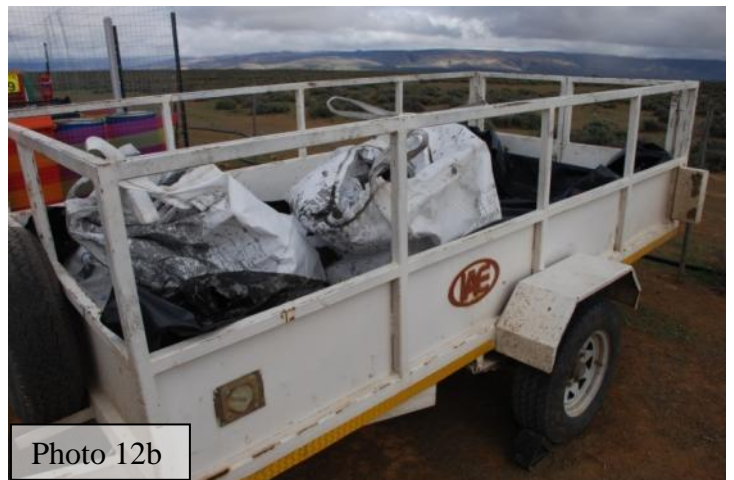
Photo 12a

AIM	ACTION TO BE CHECKED BY ECO	RESP	ACTION BY	CORRECTIVE ACTION Y/N	COMMENTS
2.7 Waste management (cont.)					
Adequate disposal of solid waste	The site should be kept neat and tidy. Any solid waste generated on site (including plastic, drilling sludge, waste cement grout etc.) must be kept in adequate waterproof containers. Solid waste must be disposed of weekly (at an approved Municipal landfill site) to prevent a build-up on site.	GEOSERVE	GEOSERVE; ECO	N	Receipts from licenced Municipal landfill sites must be kept on site. The contractor is commended on the neatness and layout of the drilling of the site. Solid waste generated on site is neatly separated and marked in adequate containers (Photo 13). Recyclables are sorted on site and put into separate bins.
	Sludge generated by the drilling process should be suitably stored in a leach proof container and be removed by Enviroserve, or transported to an Enviroserve depot for disposal at an appropriate licenced landfill site.	GEOSERVE	GEOSERVE; UJ; ECO	N	The sludge extracted from the borehole (via the SRU [Photo 11]) is stored on a trailer lined with plastic (Photo 12b). Drilling sludge will be collected and disposed of by Enviroserve.

Photos 12a and 12b: Sludge is extracted in the SRU and falls into a large plastic bag (left) which is temporarily stored in a trailer lined with plastic (top). The sludge is to be removed from site.

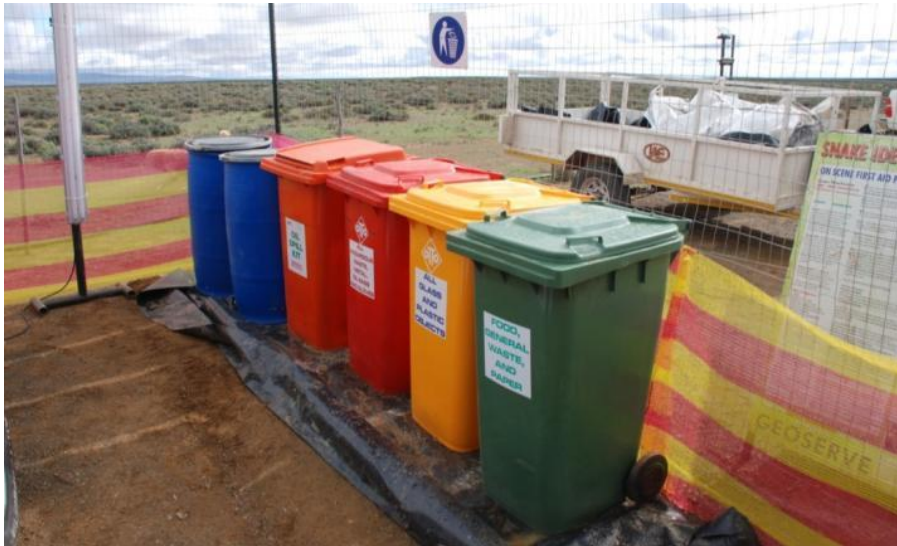
Photo 13: The contractor is commended on the neatness of the site. Solid waste generated on site is neatly separated and marked in wheeled bins. Recyclables are sorted on site and put into separate bins.

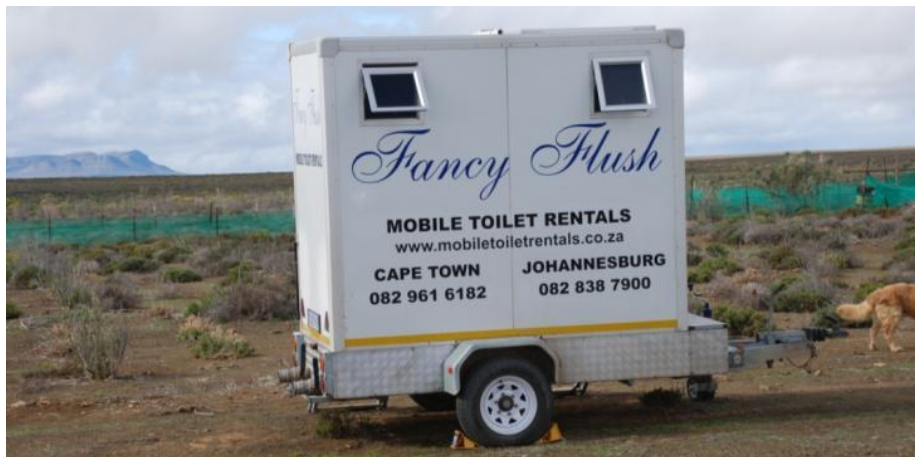
AIM	ACTION TO BE CHECKED BY ECO	RESP	ACTION BY	CORRECTIVE ACTION Y/N	COMMENTS
2.9 Sanitation provision					
Implementation of proper sanitation	One (1) portable chemical toilet should be provided for every fifteen (15) workers. Toilet paper should be provided by the contractor.	GEOSERVE	GEOSERVE; ECO	N	A mobile toilet unit (from Fancy Flush) is situated adjacent to the site (Photo 14). The unit contains two toilets (adequate for the amount of on-site personnel during a shift).
	Portable chemical toilets should be emptied once per week by the appropriate contractor.	GEOSERVE	GEOSERVE; ECO	N	Service receipts must be kept on site
	Portable chemical toilets should be placed in a suitable location, on even ground, be appropriately secured to prevent being blown over and may not be closer than 100m from a drainage line.	GEOSERVE	GEOSERVE; ECO	N	The mobile toilet is parked on level ground, and is also secured by plastic tyre chocks (Photo 14).

Photo 14: A mobile toilet unit is parked adjacent to the site. The mobile toilet is located on even ground, secured by plastic tyre chock blocks.

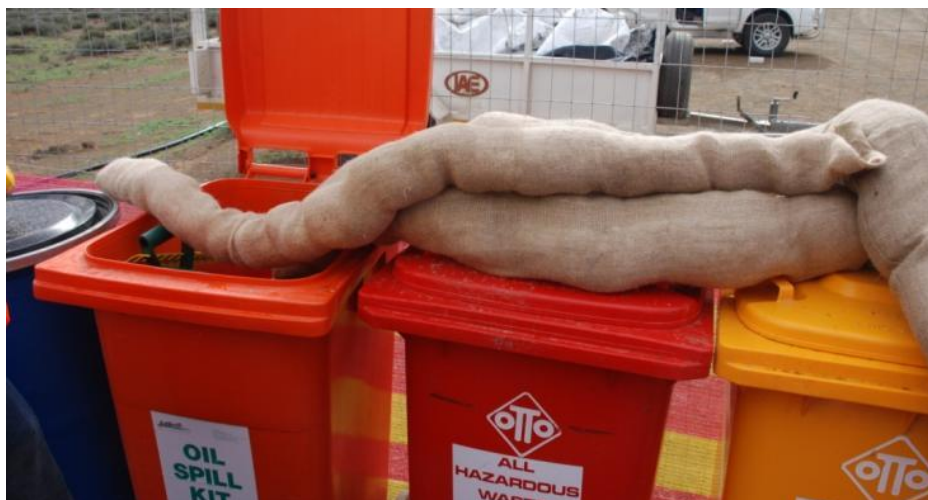
Photo 15: A petro-chemical spill kit is present on site which will be used in the event of a fuel, oil or lubricant spill. Any contaminated soil will be rehabilitated with Terrasweep and Terrafix and removed from site to Vissershok.

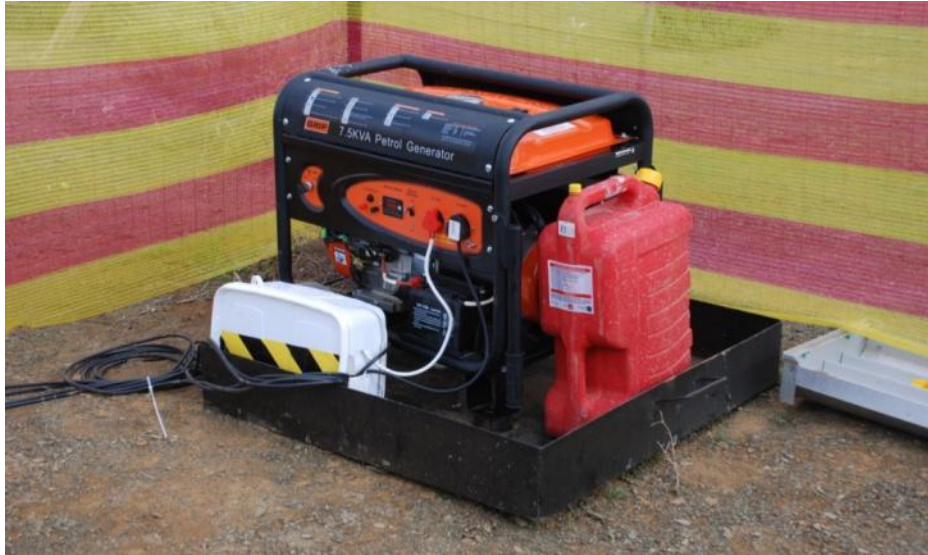
Photo 16: A drip tray is present beneath the generator in the southwestern corner of the site.

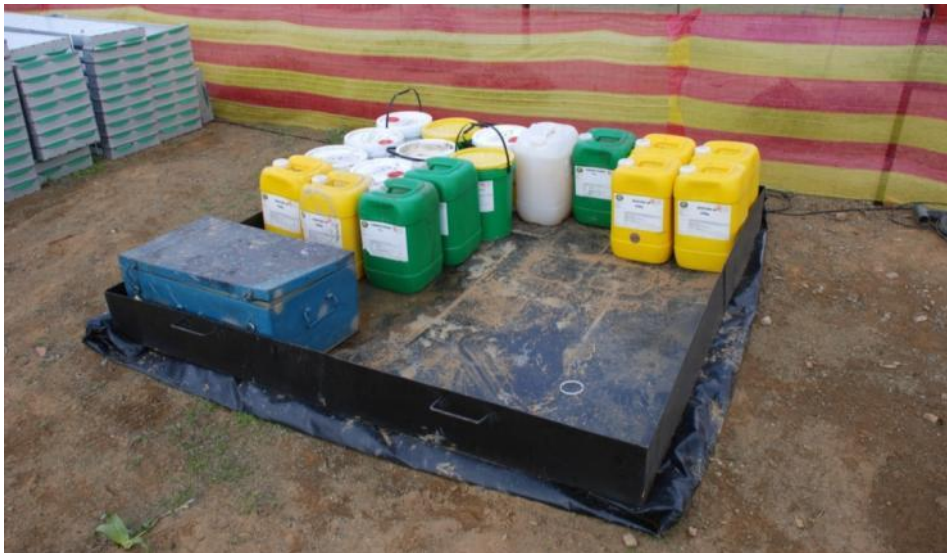
Photo 17: A drip tray is present beneath the stored chemicals.

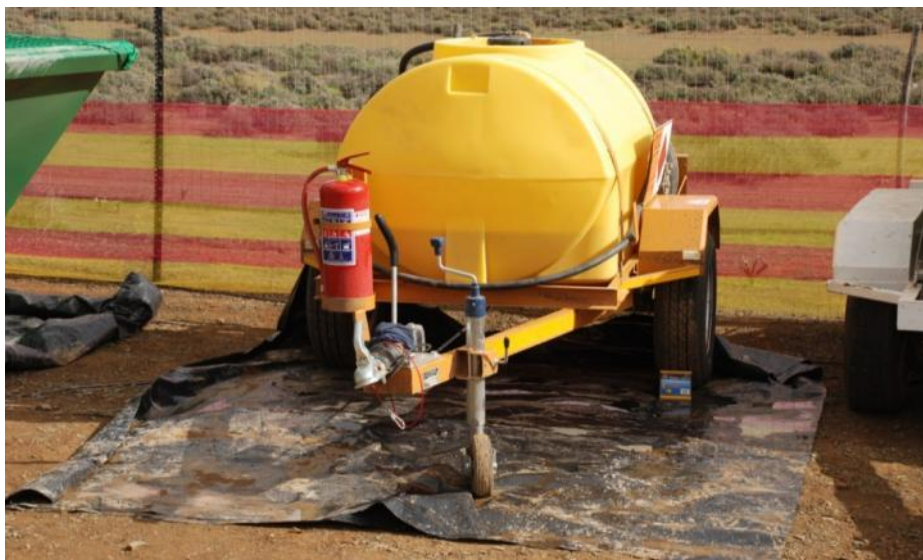
AIM	ACTION TO BE CHECKED BY ECO	RESP	ACTION BY	CORRECTIVE ACTION Y/N	COMMENTS
2.10 Vehicle and machinery management (cont.)					
Parking of vehicles and mechanical machinery	Parking areas for the storage of the diesel bowser and the drill machine must be prepared with a plastic liner on top of the soil. The liner should be covered with a thin layer of sand or shaley gravel. Such soil covering is to be removed from site and dumped at an appropriate landfill site when drilling has been completed.	GEOSERVE	GEOSERVE; ECO	N	A mobile oil storage unit which is parked on level ground (lined with plastic) and secured with tyre chocks is used (Photo 18).

Photo 18: A mobile diesel bowser is parked on level ground (lined with plastic) and secured with tyre chocks.

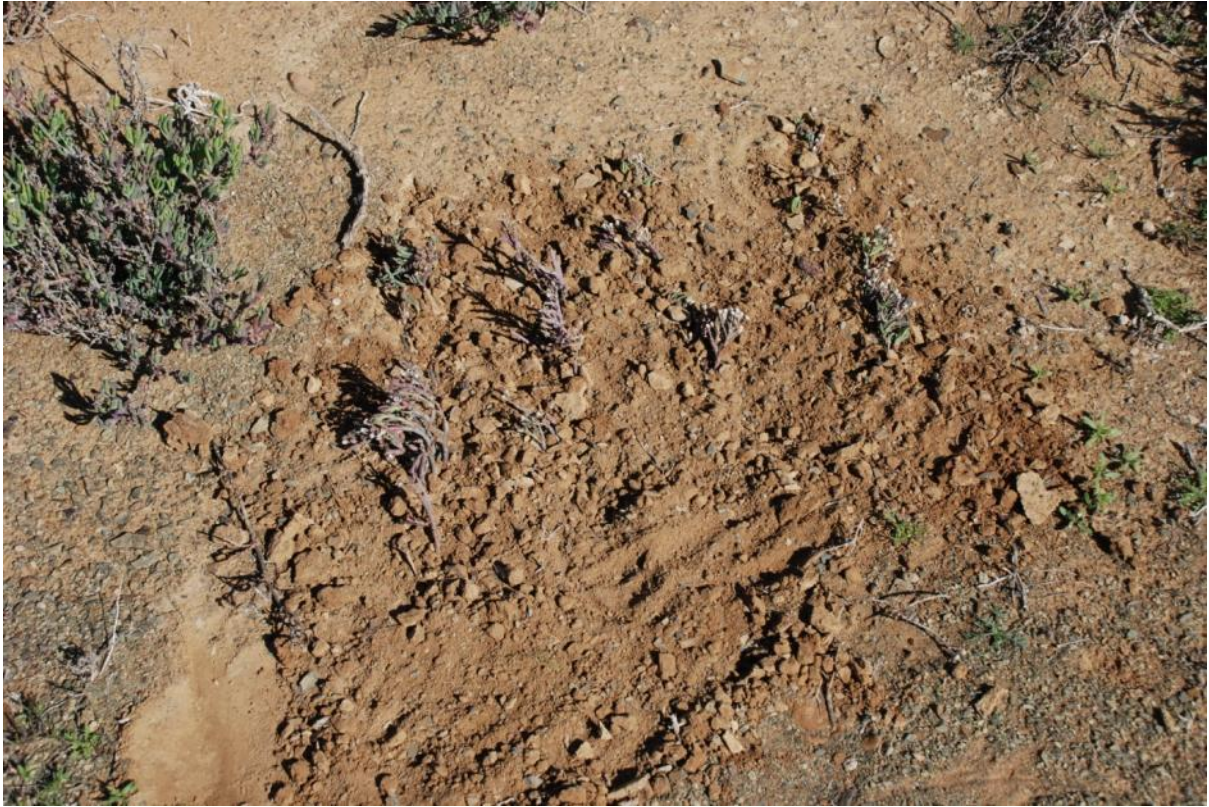
Photo 19a: Cuttings of various succulent species found around the site were planted in an appropriate on-site location by the ECO for later use in rehabilitation.

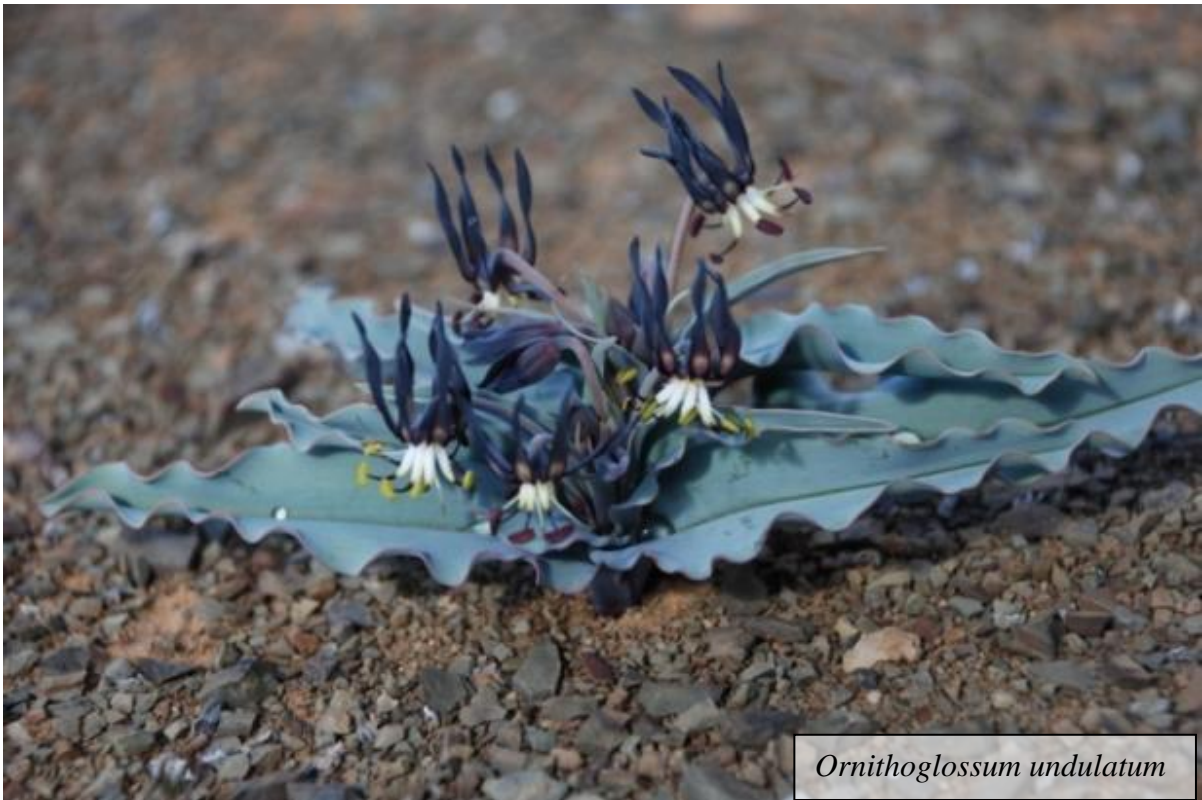
3.2 Rehabilitation of drill site and access roads					
Rehabilitation of disturbed areas and damaged access roads	Any disturbed areas must be rehabilitated by scarifying the surface, replanting rescued plants; scattering any locally collected seeds (by the ECO). Once rehabilitation has been completed, the area should be lightly sprayed with freshwater if the soils are dry. Any available brushwood (or straw) should be spread over the rehabilitated areas.	GEOSERVE	GEOSERVE	N	Cuttings of various succulent species found around the site were taken and planted in an appropriate on-site location by the ECO (Photo 19a) for later use in rehabilitation. Seeds from surrounding indigenous Tankwa Karoo Succulent Karoo vegetation unit were collected and will be stored for use in the rehabilitation of the drill site. Various bulbs were rescued from the site (e.g Karoo Slangkop. <i>Ornithoglossum undulatum</i> [Photo 19b]).

Photos 19b: Various bulbs were relocated from the drill site to a “nursery” area for later transplanting during rehabilitation, e.g. Karoo Slangkop *Ornithoglossum undulatum*.
