### **PROJECT REPORT UPDATE – CIMERA KARIN PROJECT – WILLOWVALE**

**AUG/ SEPT 2015**

## INTERNAL AUDIT TEAM SUMMARY

SHEQIA01/2015

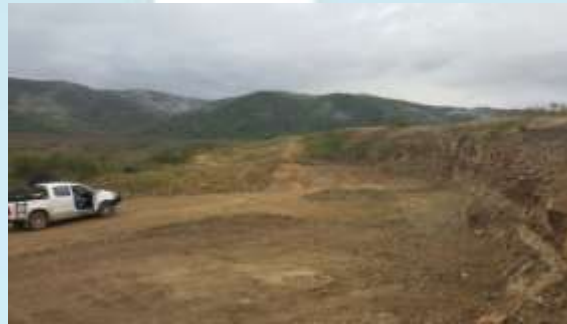
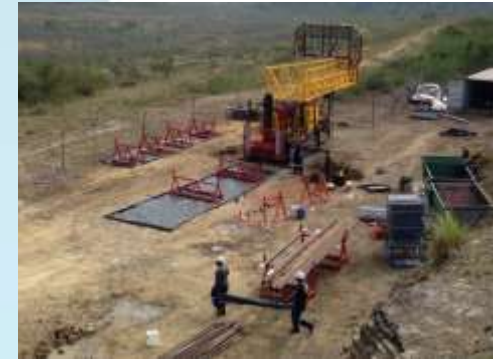
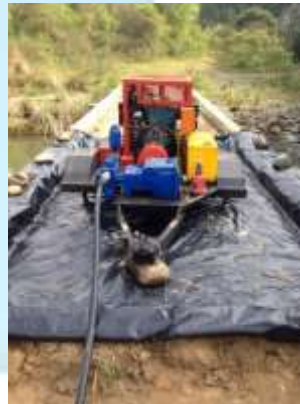
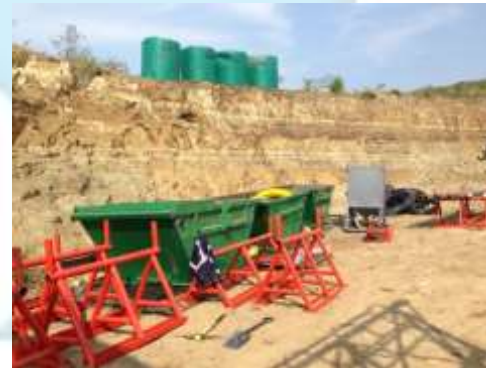
*Site Mobilization. Waterpoint allocated at river crossing. All working areas bunded – spillage control. Waterpumps situated at river bunded and general local worker employed to monitor water pipeline for any water leaks etc. Machine cemented on 500cm block and bolted on for stability and prevention of rig falling over*

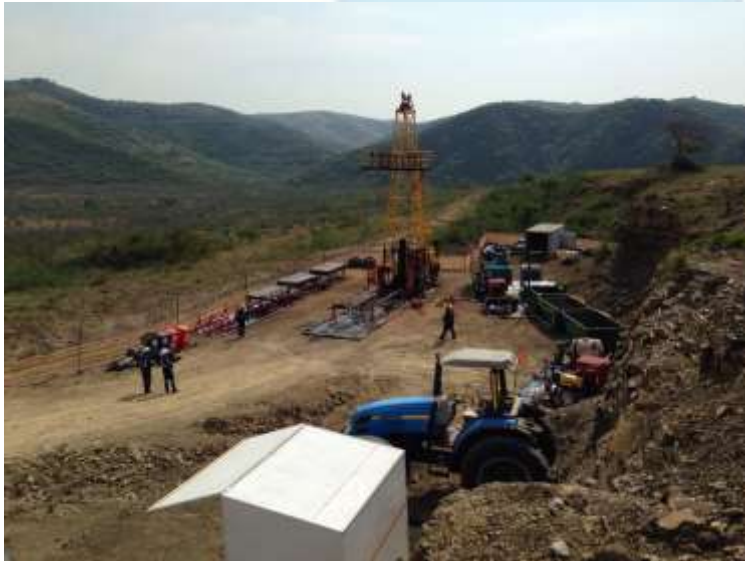
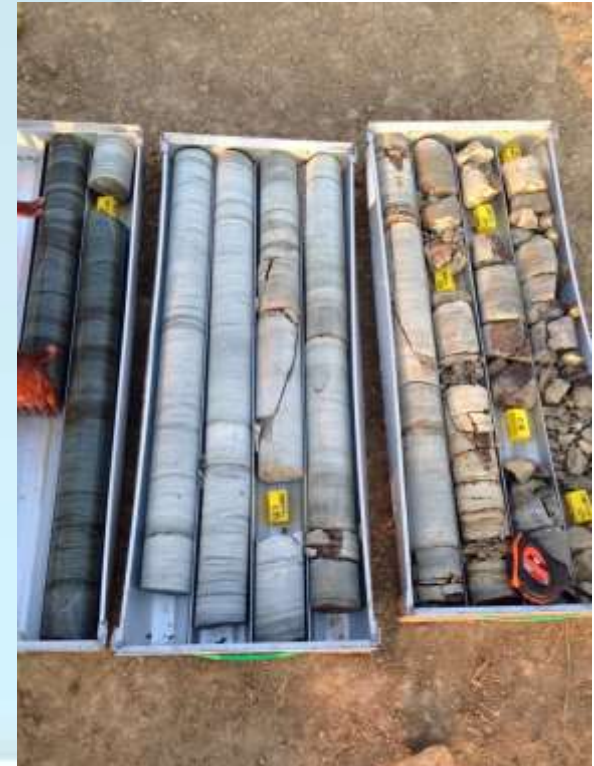
**27 August Thurs 2015**– Started drilling- Hole KVV01. 0 – 2m

**28 August Friday 2015** - continued drilling 2 – 10,22m.

Setting up Solids Removal Unit – SRU.

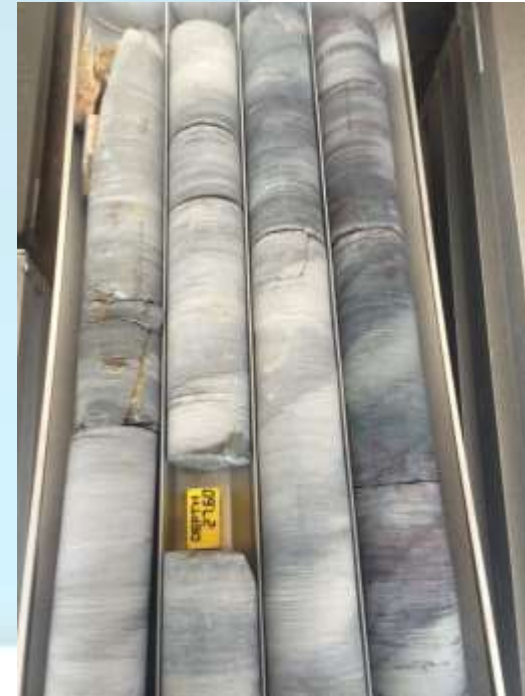
**31 August 2015** – Continued Drilling 10,22m - 18,50m. Pulling rods in order to ream the hole for installation of casing.

**1 September 2015** – 18,50m – 27,60m Hard formation. Experiencing waterloss

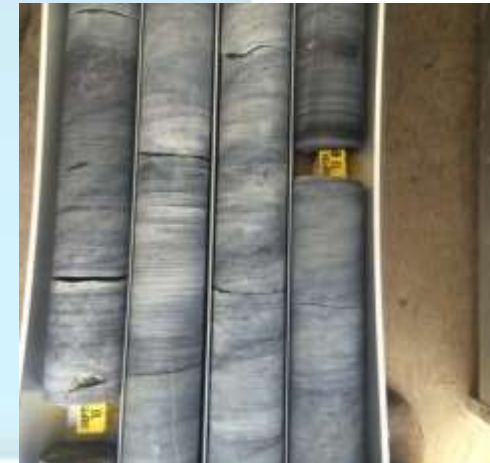
**4 September** - Continued drilling – 67,07m – 82,10m. Stopped for maintenance.  
Hard formation and waterloss.

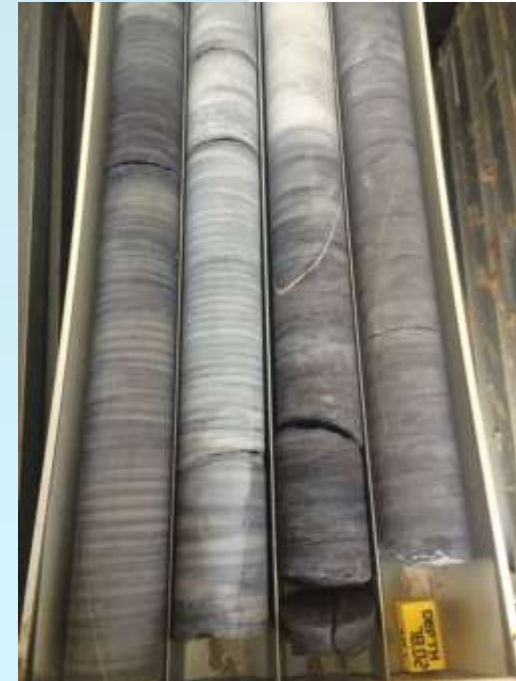
5 September - Continued Drilling - 82,1m – 109,22m.(27m for shift) Changed bit PQ3 6 series to a PQ3 9 series. Penetration rate increased. Formation changed.

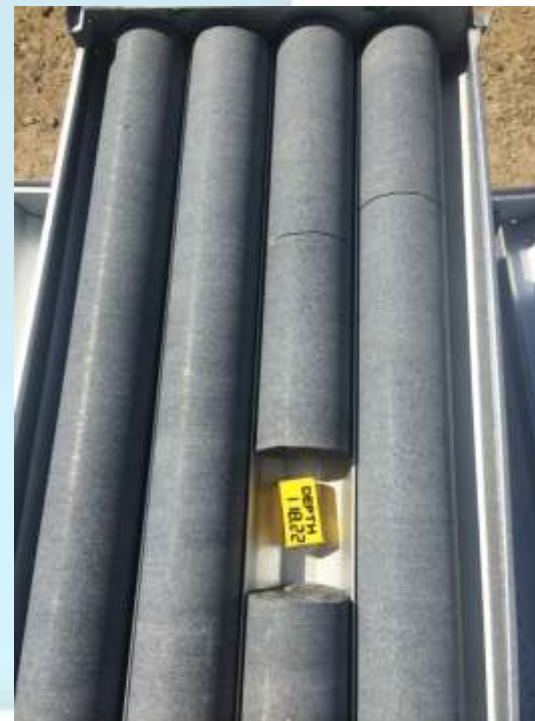
7 September 2015 - Continue Drilling – 109,22 – 148,22. – (39m for shift) Dolomite formation. Penetration rate still increasing

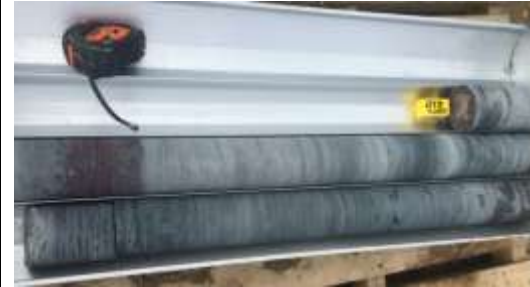
**08/09/2015** – Starting depth – 148,22 – 175,22 – (27,00m)

Wireline broke - pulled rods lost 1,5 hrs.

2 hrs to rectify core depth. Incorrect core depth calculated – difference +3m. Issue rectified.

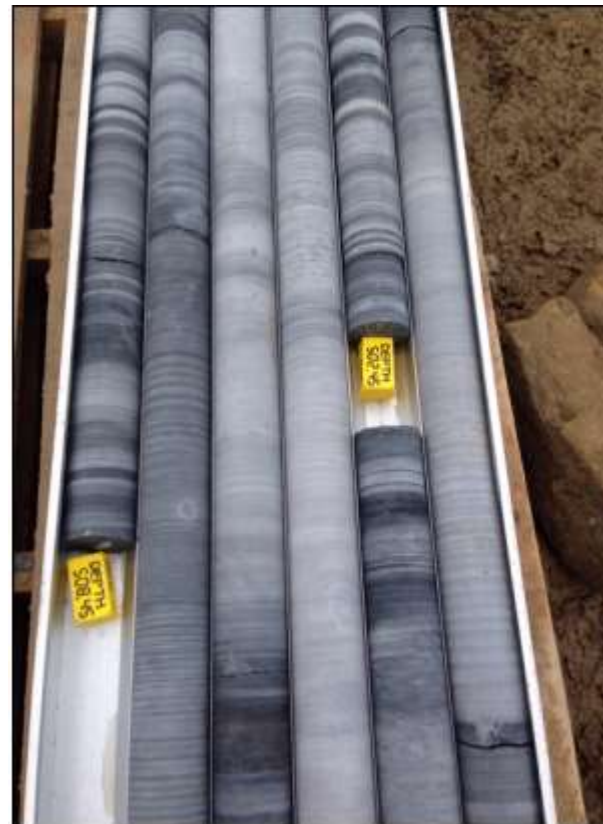
**18/09/2015 – Starting depth - 346,2 – 409,45 - (62,81m)**

**21/09/2015 – Starting depth – 448,45 – 508,45**
